Archaeological Investigation of the Garden Terrace, Kitchen Dependency and Corner Terraces

by John Metz
with contributions by
Lisa Kealhoffer,
Leslie McFaden,
Fraser Neiman and
Derek Wheeler

November 2000

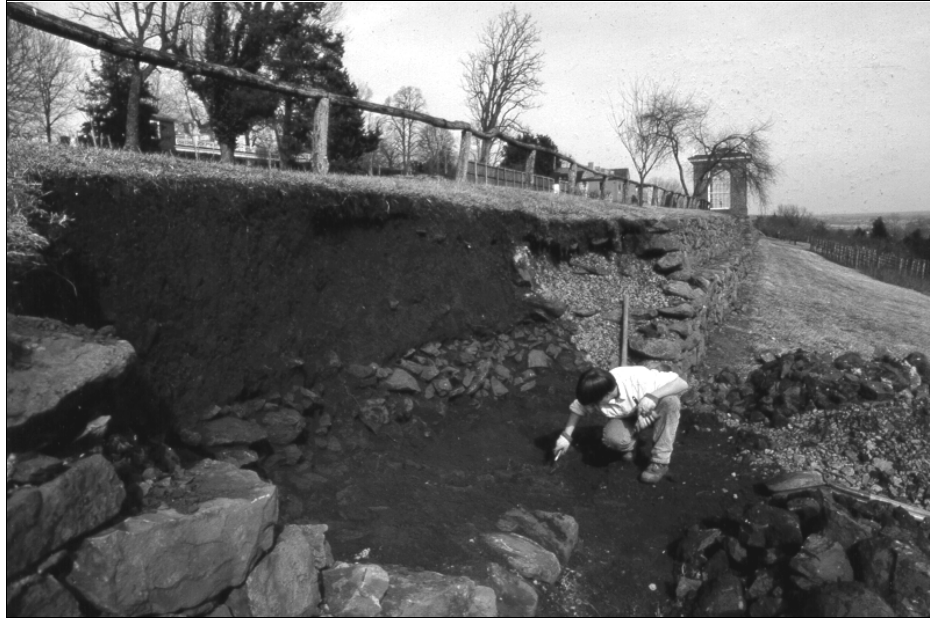
Figure 2. *Initial investigation of collapsed section of Garden Wall.*

The portion of the restored garden wall that collapsed in November 1996 was documented by the Monticello Department of Archaeology between February 19 and 21, 1997 (**Figure 2**). The collapsed retaining wall revealed a profile of the original garden terrace measuring eight-and-a-half feet wide by six feet high and consisting of six layers (**Figure 3**). The uppermost layer (cxt.2050-A) averaged seven tenths-of-a-foot thick and consisted of dark reddish brown (2.5YR2.5/4) loam. Modern artifacts such as wire nails and PVC pipe observed in this layer attest to current cultivation of the garden terrace. The second layer (cxt.2050-B) was six tenths thick and consisted of red (2.5YR4/6) clay loam. Despite the presence of Jefferson-period nail rod, plastic and soda bottle glass found in this layer suggest that it dates to the twentieth century. The third layer identified (cxt.2050-C) was a sterile band of red (2.5YR4/8) clay which measured nearly two feet thick. The clay was devoid of artifacts and appears to represent re-deposited B-horizon. The third layer also appears to be an original fill layer of the garden terrace completed by 1809. Beneath

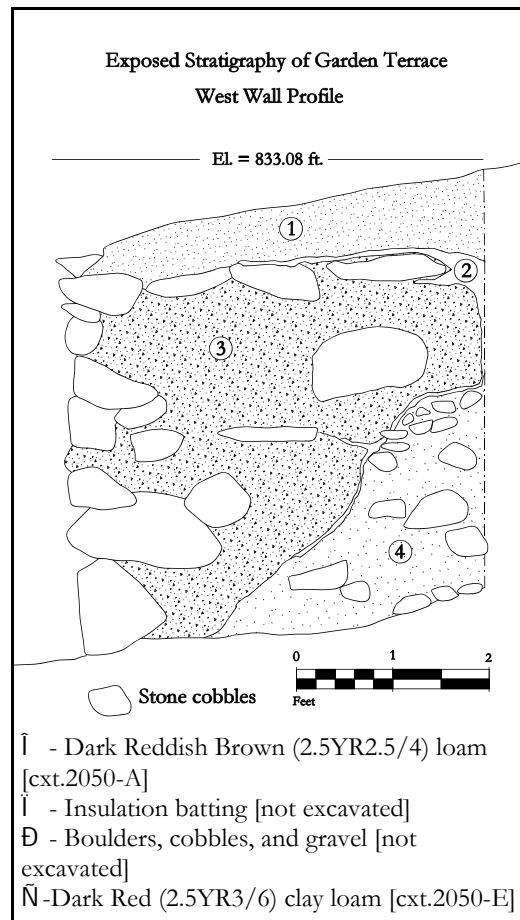
Figure 4. *West profile of collapsed garden terrace wall.*

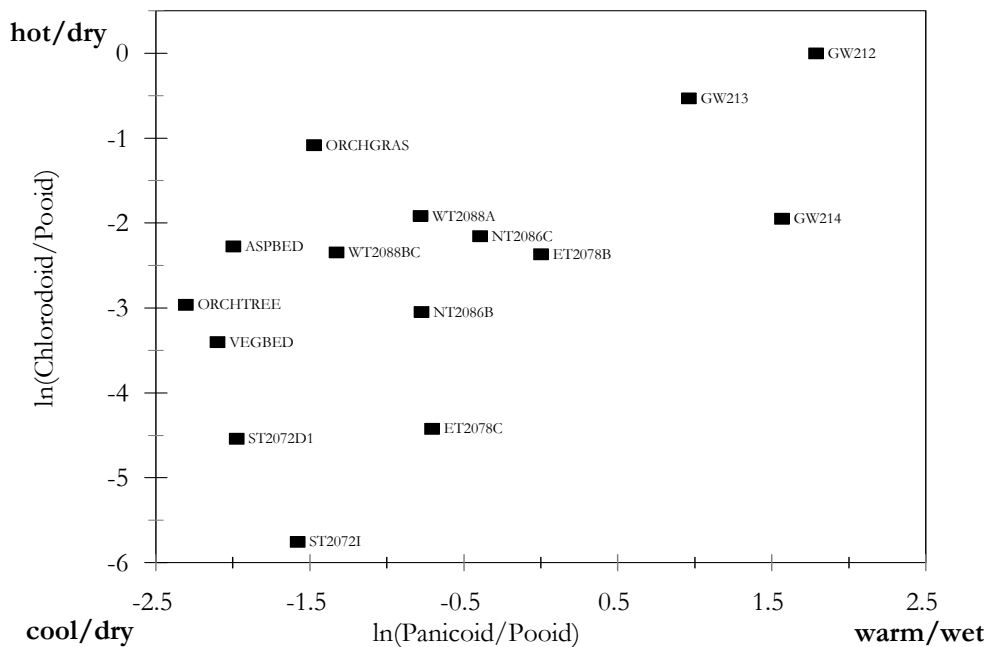
Figure 5. *Graph showing on the x-axis the relative cool/dry (left) versus warm/wet (right) conditions of phytolith sample locations and on the y-axis relative cool/dry (bottom) versus hot/dry (top).*

The x-axis in **Figure 6** contains the same Panicoid-Poooid ratio as in **Figure 5**, but the y-axis was replaced by the ratio of arboreal phytoliths versus total grass phytoliths. While the Garden Wall samples still remain distinct (due to the high ratio of Panicoid versus Poooid grass phytoliths), the three samples are not distinguishable from the remaining twelve samples based on the ratio of arboreal-grass phytoliths. The Garden Wall samples contain the same number or more grass phytoliths than the four modern context samples, but they contain fewer grass phytoliths than all the Corner Triangle samples with the exception of the South Corner Triangle.

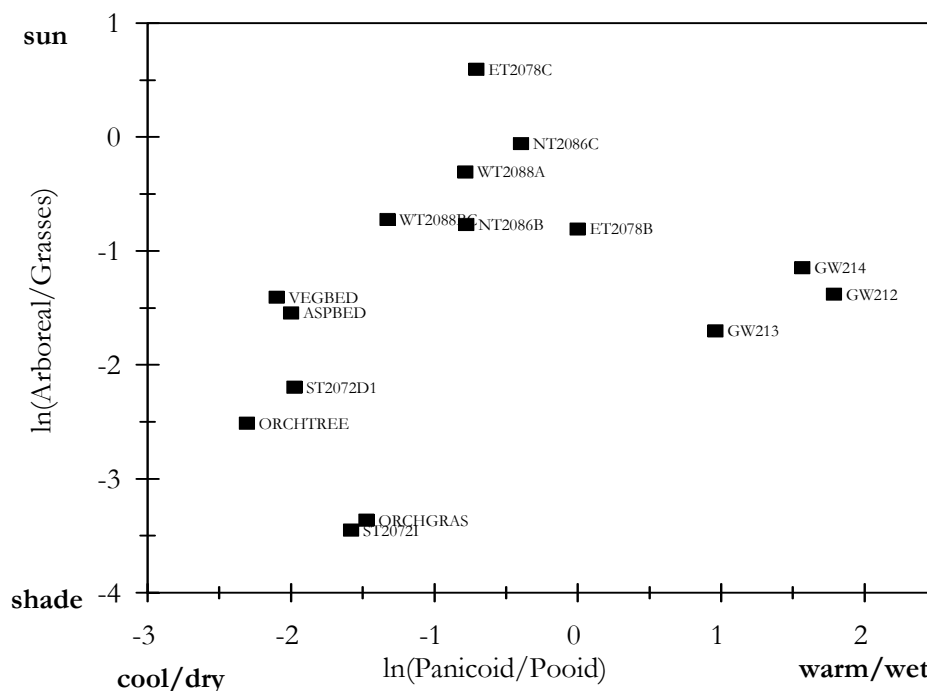
Figure 6. Graph showing on x-axis the relative cool/dry (left) versus warm/wet (right) conditions of phytolith sample locations and on the y-axis the relative shade (bottom) versus sun (top).

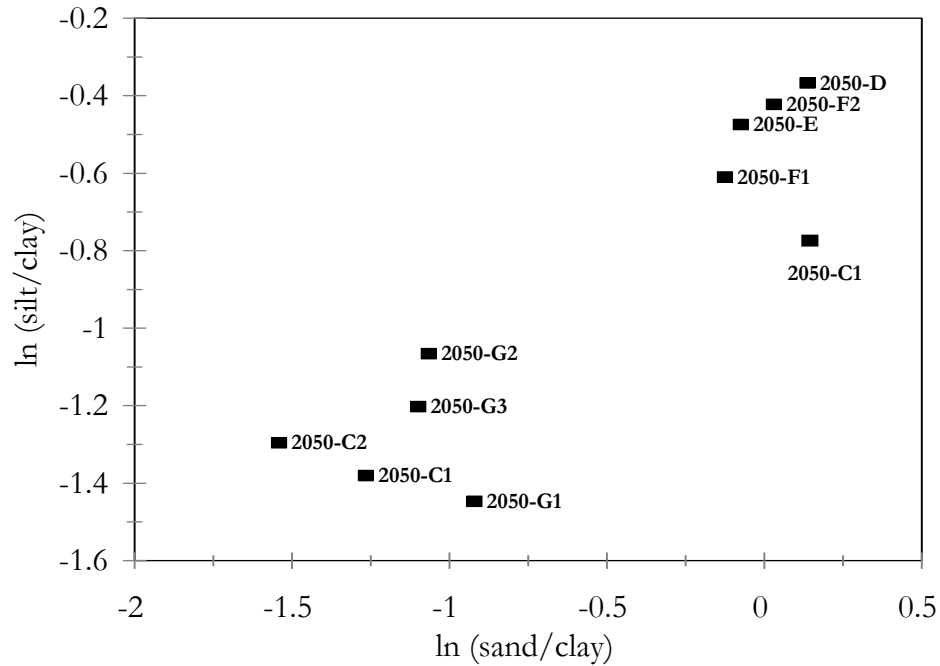
Figure 7. *Texture of garden wall samples.*

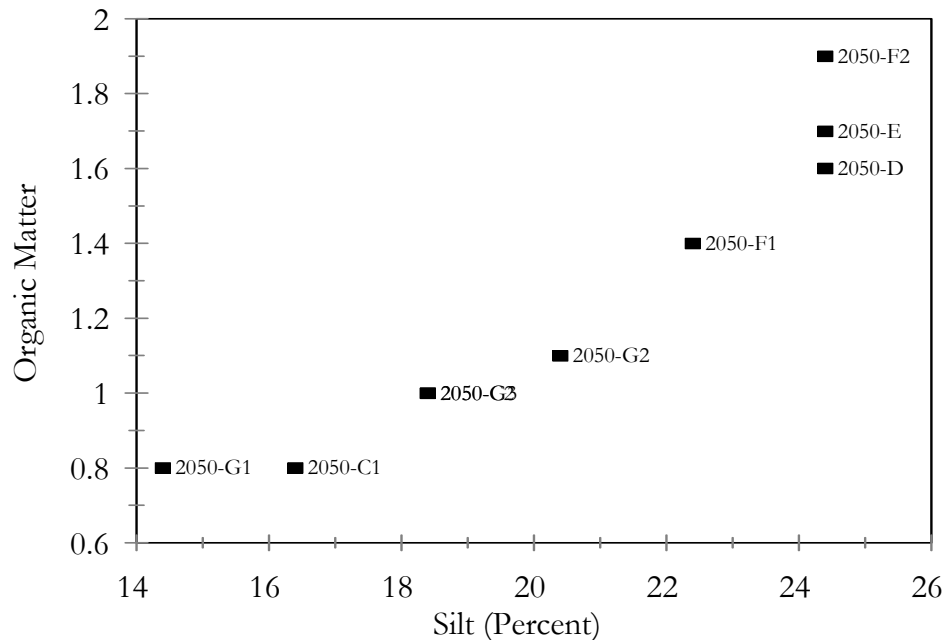
Figure 8. *Linear relationship between percent silt and organic matter.*

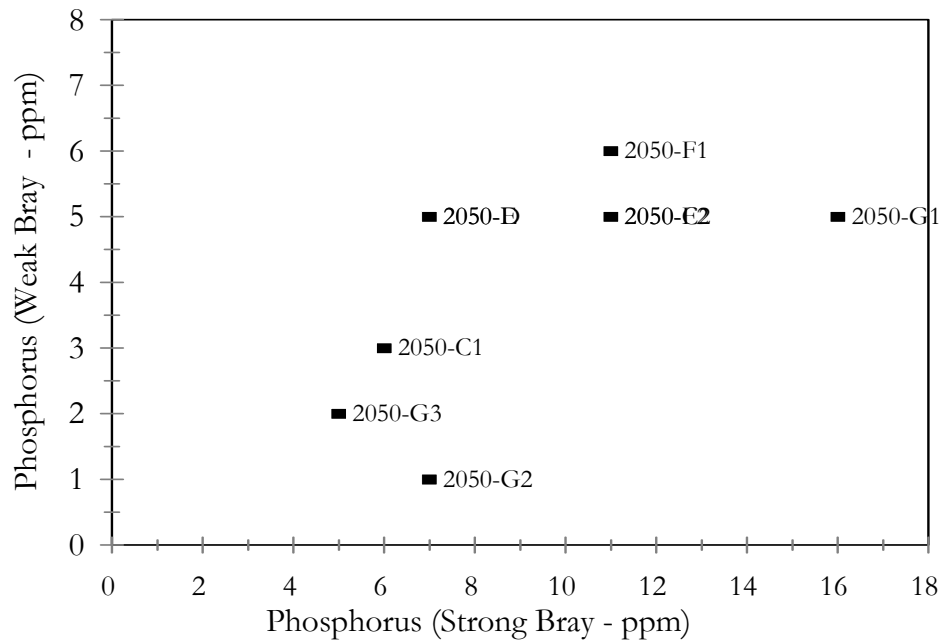
Figure 9. *Correlation between Phosphorus counts as determined by the strong Bray (P_2) and weak Bray (P_1) tests.*

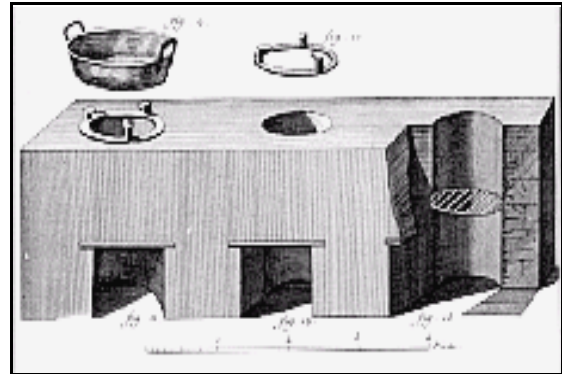
Figure 10. *Stew stove shown in Diderot's L'Encyclopédie (1776-1777).*

Built of brick and stone masonry, the stew stove resembled a waist-high counter with openings or "stew holes" in the top, much like a modern-day stove. Pots and pans rested on iron grates covering the stew holes, while an iron basket within each hole held burning charcoal. Ashes fell into a pan below and were removed through a door or opening in the front of the stove (Figure 10). Jefferson engaged ironfounder Henry Foxall of Georgetown to make the iron baskets and grates for a stew stove in 1809. An invoice found among Jefferson's papers indicates that the task was completed and Jefferson paid for the grates (Revell 1996:59). An architectural sketch (N-56) completed in 1772 of the first kitchen in the basement of the south Pavilion shows five stew holes. Plans for the new kitchen completed in 1809 also included stew holes. Eight or nine stew holes are shown in one drawing (N-56) for this kitchen, while in another (N-150) dated 1796, thirteen are shown along the south wall where the window would have provided ventilation (Revell 1996:59) (Figure 11).

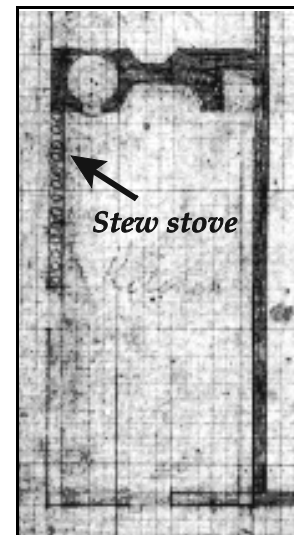
Figure 11. *Jefferson's plan for the kitchen, 1796.*

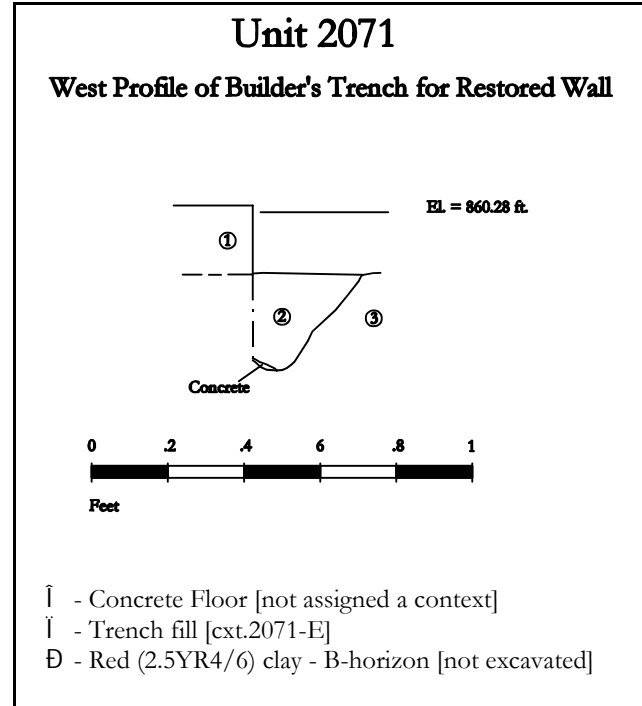
Figure 13. Profile of builder's trench for restored wall in kitchen.

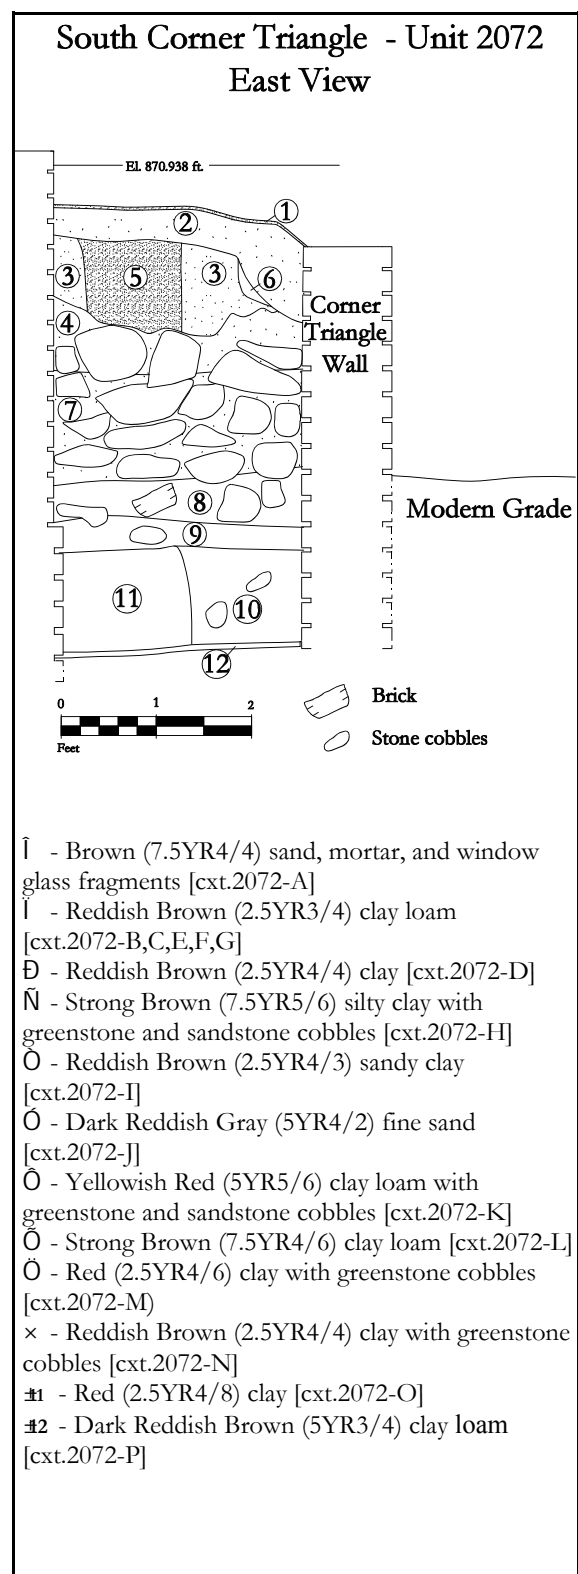
Figure 17. East profile of Test Unit 2072 in the South corner triangle.

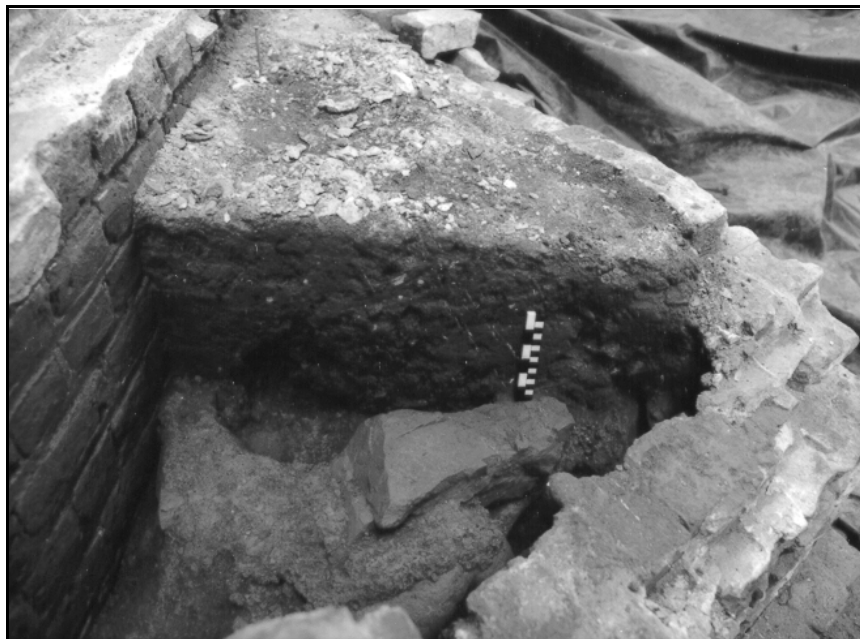
Figure 18. *View of circular planting hole (cxt.2072-I).*

The third layer was intruded by a circular feature (cxt.2072-I) which was roughly centered in the triangle and measured a foot in diameter. Only half of the feature was exposed in unit 2072. Excavation of reddish brown (2.5YR4/3) silty clay loam revealed a u-shaped cross section nine tenths-of-a-foot deep with a large fragment of brown, transfer-printed whiteware at the bottom. Once again, architectural debris, including 68 pieces of window glass, accounted for 118 of the 126 artifacts found in the hole. The large piece of brown, transfer-printed whiteware found at the bottom of the hole post-dates 1829, and likely dates to the Levy period of occupation (1834-1923). This feature probably represents a planting hole based on its shape and its position in the center of the triangle (Figure 18).

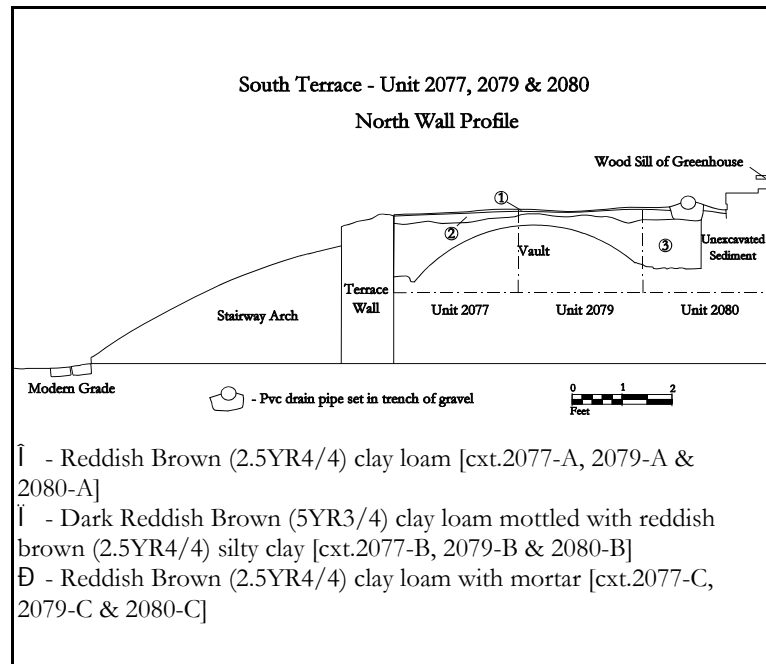
Figure 19. North profile of Test Units 2077, 2079, and 2080 in the South Corner Terrace.

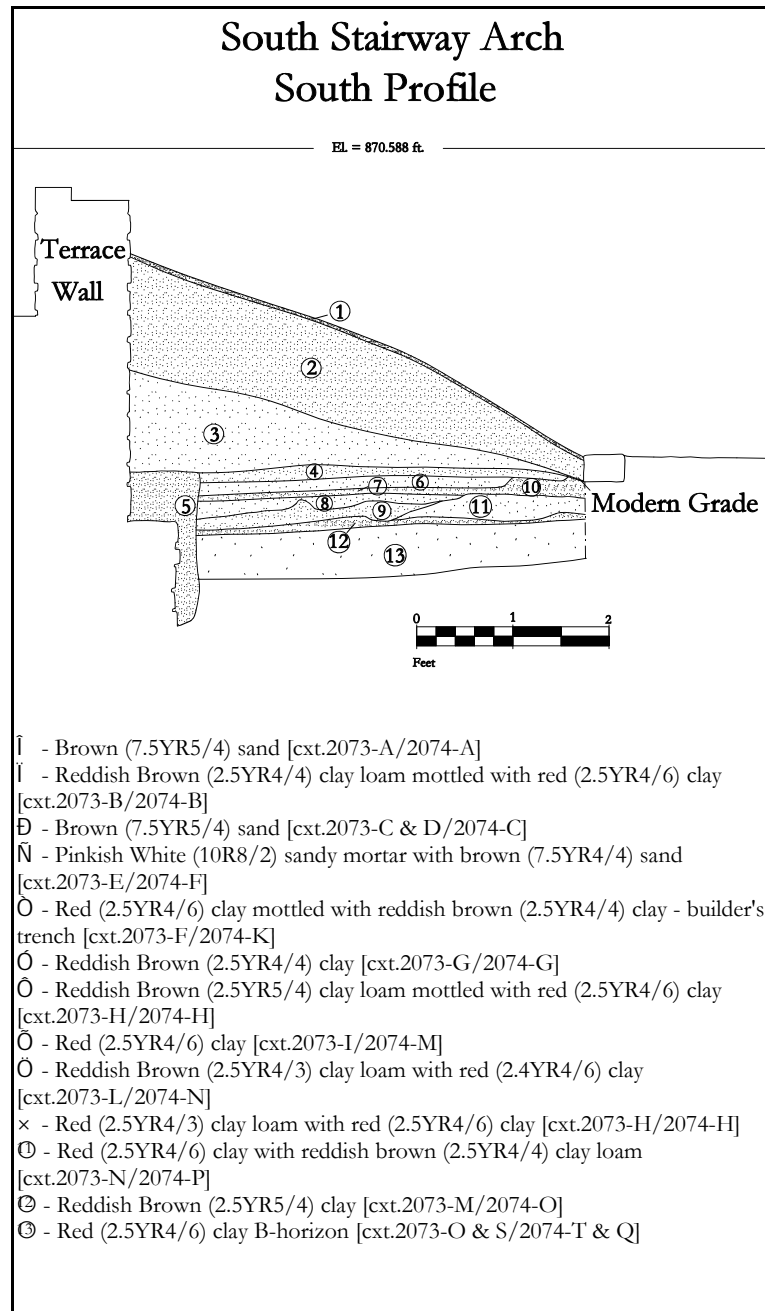
Figure 21. South profile of South stairway arch (Test Units 2073 & 2074).

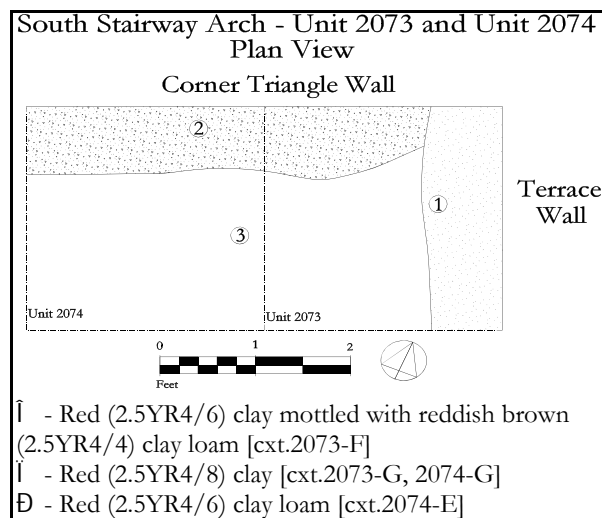
Figure 22. Plan view of builder’s trenches in South stairway unit (cxt.2073-F & cxt.2073-G/2074-G).

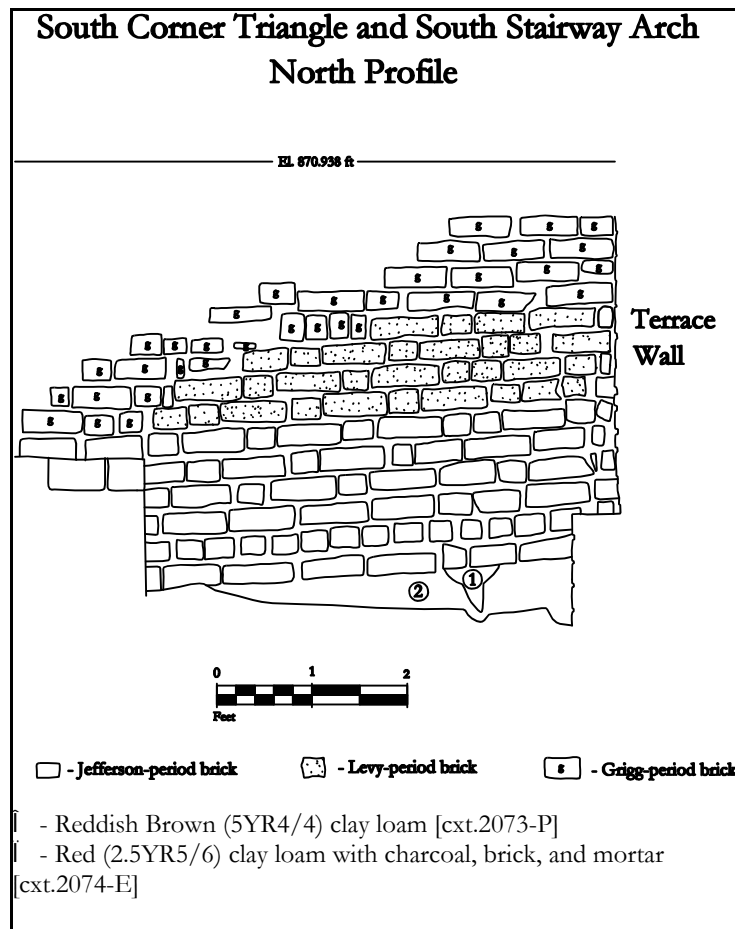
Figure 23. North profile of Test Units 2073 and 2074 showing brickwork of the South corner triangle wall.

The exterior of the south wall of the south corner terrace was exposed in test units 2073 and 2074 (**Figure 23**). The lowest three courses of this wall were laid in common bond while the upper courses were laid in flemish bond. This may indicate that the original grade existed above the third course and that the section laid in

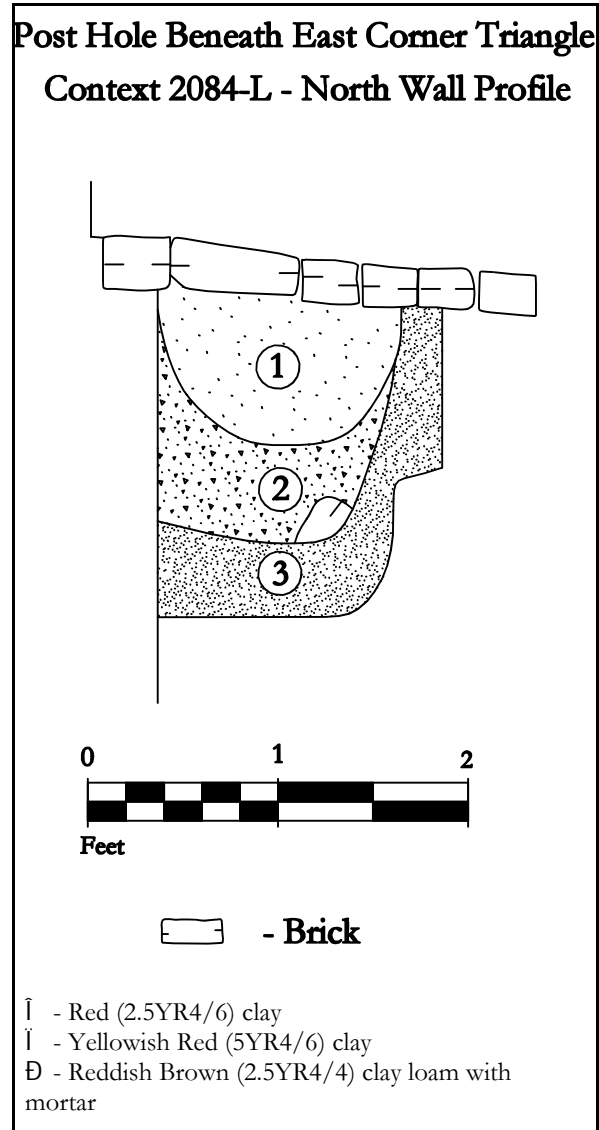
Figure 29. North profile of post hole (cxt.2084-L) beneath East corner triangle wall.

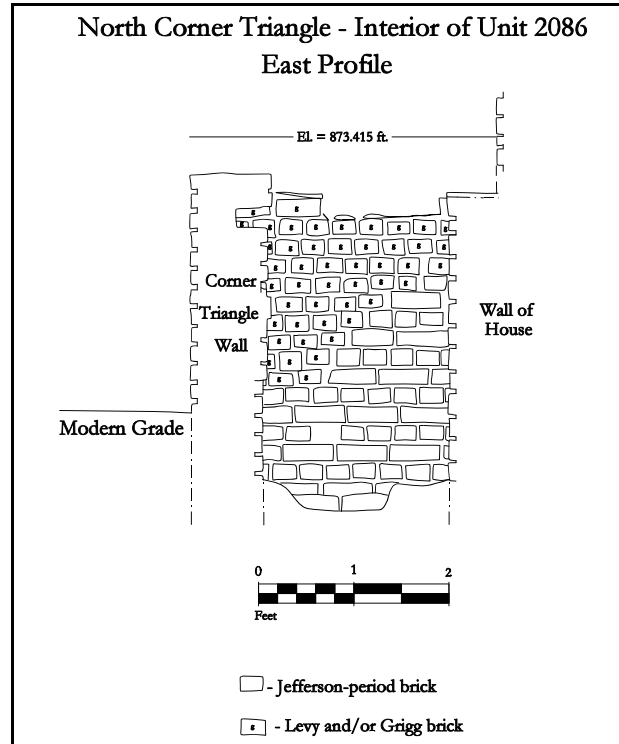
Figure 36. *View of interior brickwork in east wall of the North corner triangle.*

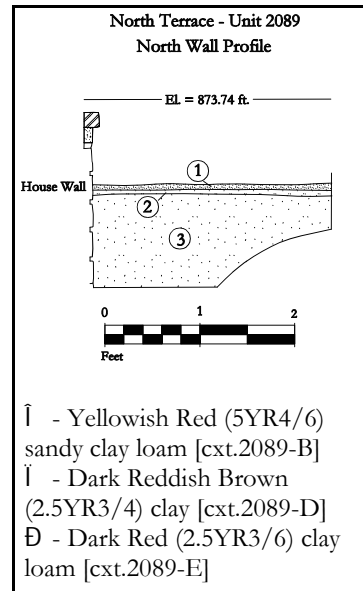
Figure 37. North profile of Test Unit 2089 in the North Corner Terrace.

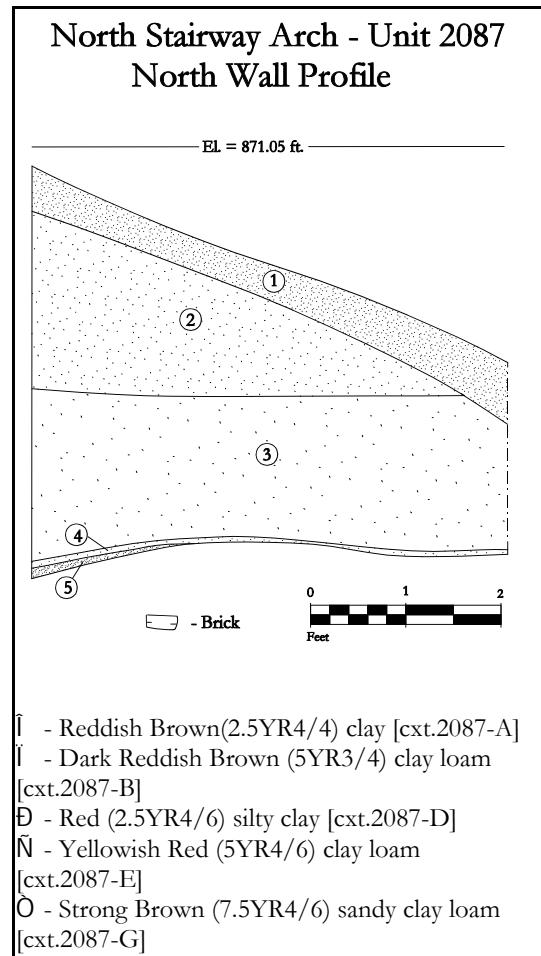
Figure 40. North profile of Test Unit 2087 in North stairway arch.

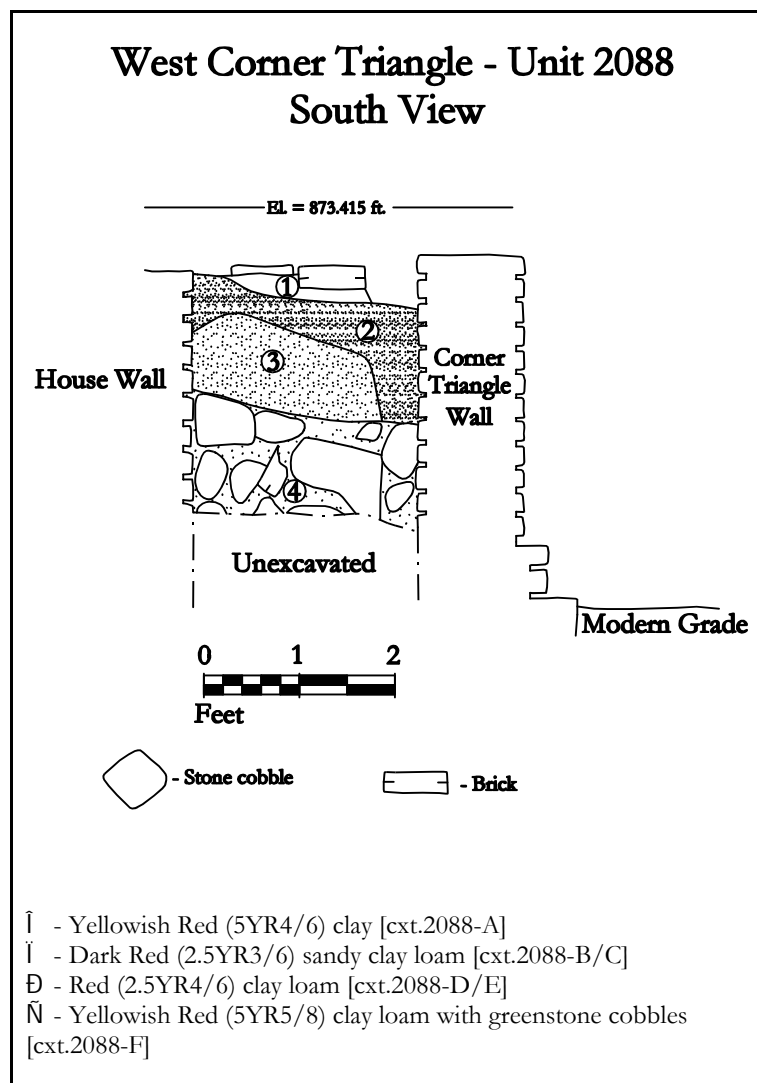
Figure 44. *South profile of Test Unit 2088 in the West corner triangle.*

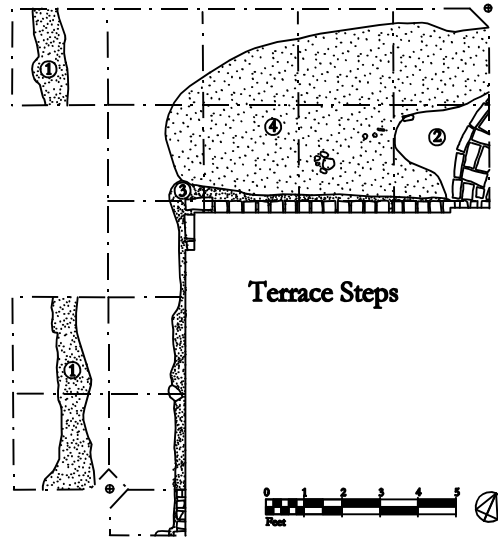
Plan View - Unit 2055 through Unit 2070 & Unit 2076
Features Associated with the West Terrace Cheek Wall

- 1 - 20th-century utility trench [not excavated]
- 2 - Reddish Brown (2.5YR4/4) clay loam mottled with dark red (2.5YR4/6) clay and brick fragments [cxt.2055-F] - Shallow feature associated with the decorative brickwork
- 3 - Dark Reddish Brown (2.5YR3/3) sandy clay included with brick and mortar [cxt.2056-E, 2058-C, 2059-D, 2060-C, 2061-F & 2076-D] - Shallow trench associated with the rebuilding of the cheek wall
- 4 - Dark Reddish Brown (2.5YR3/3) silty loam with mortar inclusions - Debris associated with Grigg's restoration in the 1930s [cxt.2055-C, 2056-C, 2058-D, 2059-E, 2062-B, 2063-B & 2064-B]

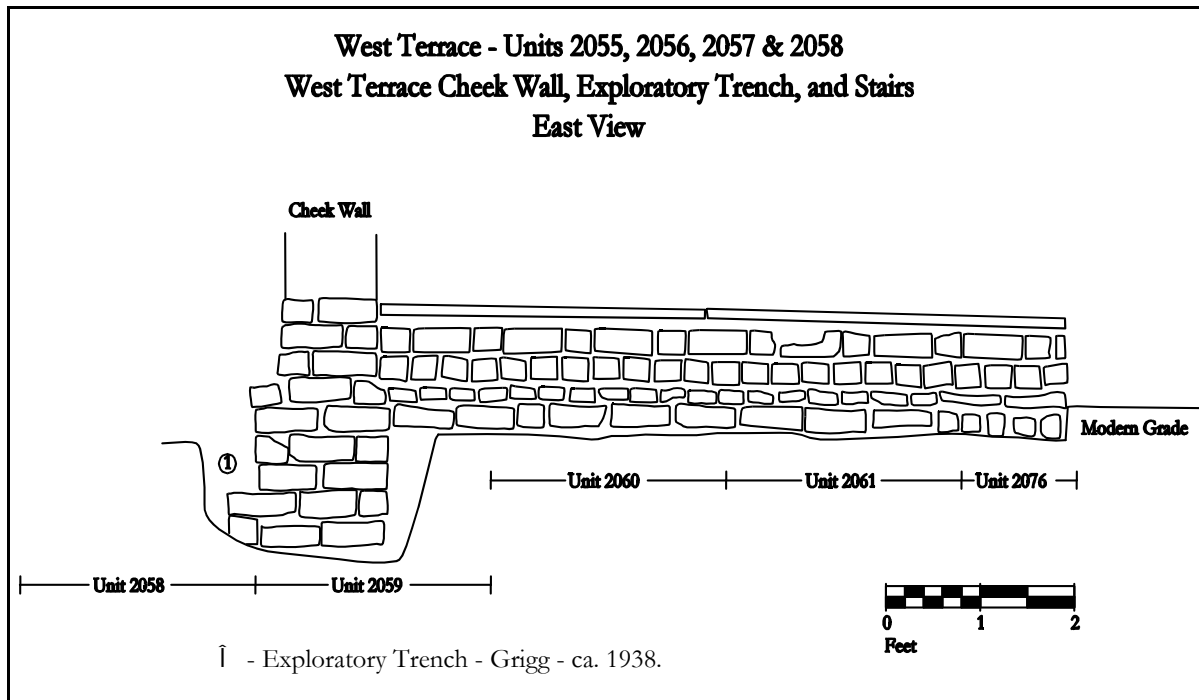
Figure 46. *East view of West Corner Terrace cheek wall.*

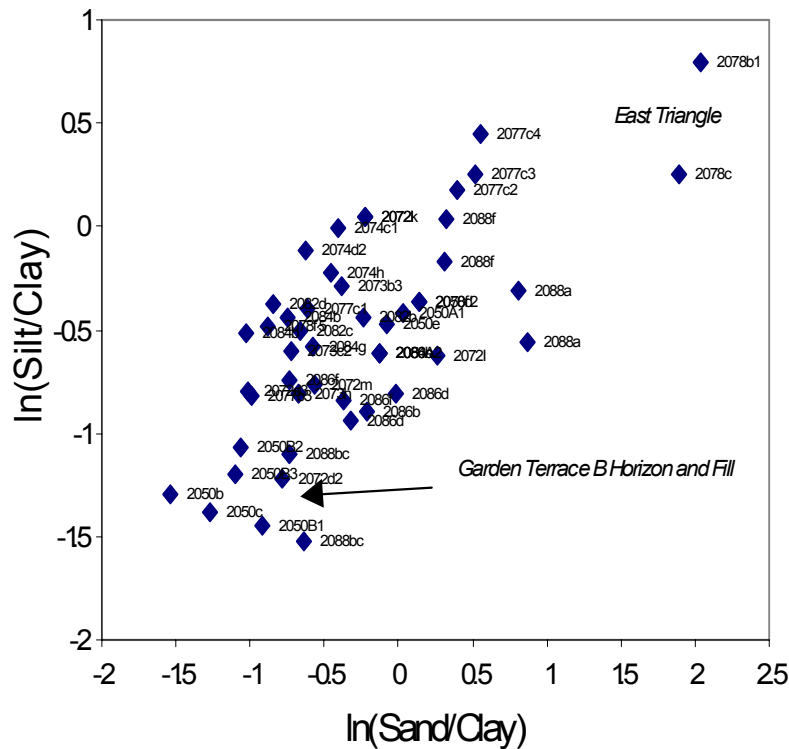
Figure 48. Relationship between silt and sand frequencies, relative to clay.

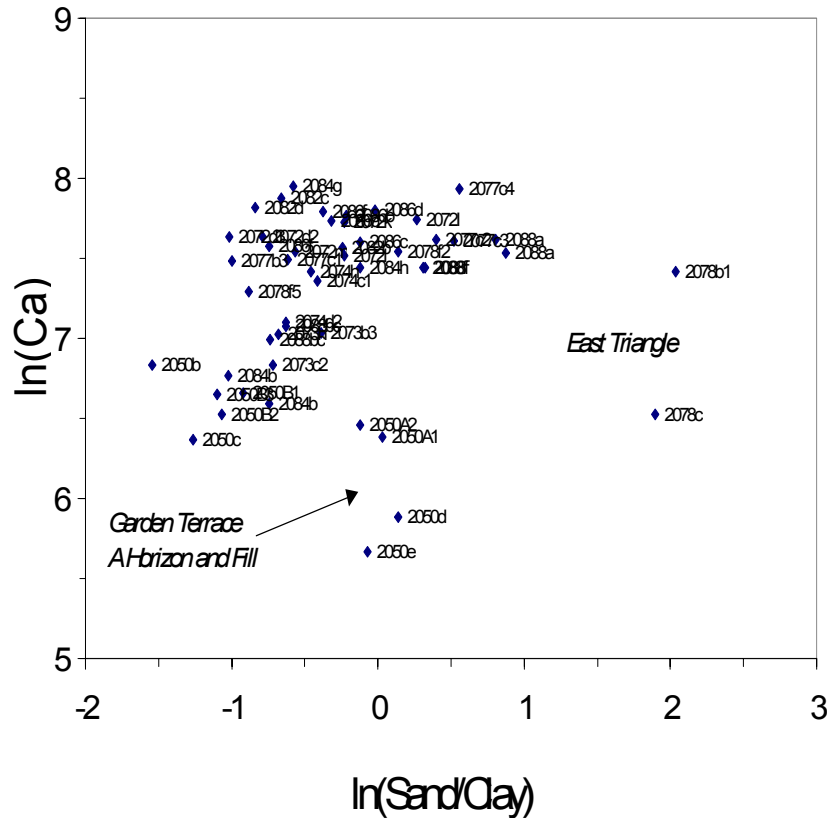
Figure 49. Relationship of calcium levels to sand frequency.

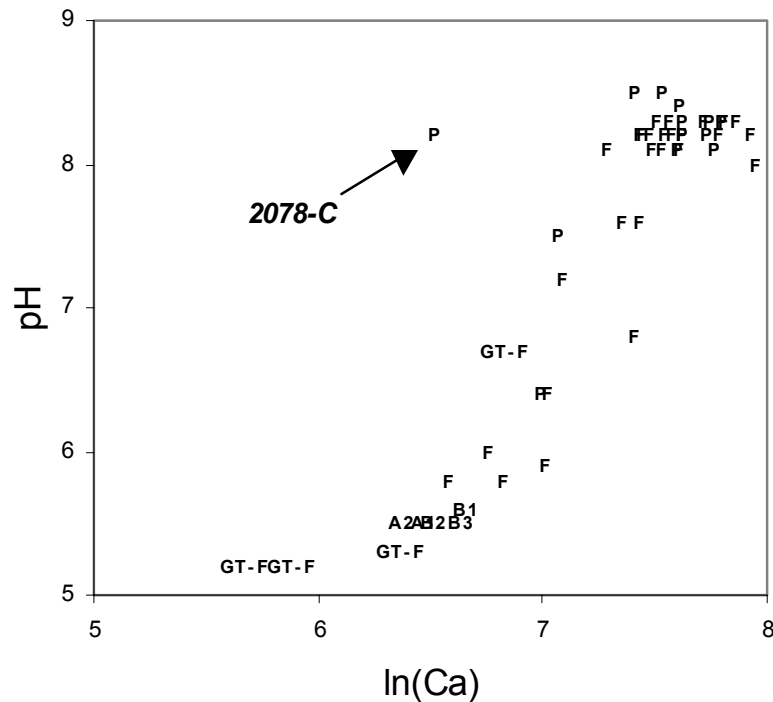
Figure 50. Relationship between calcium and pH levels. KEY: P - probable planting layer; F- fill layer; GT- Garden Terrace.

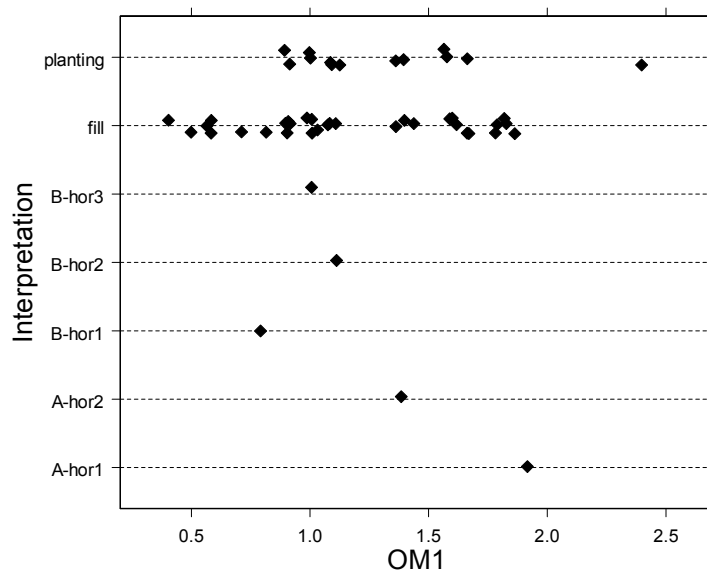
Figure 51. *Organic matter (percent) as measured by colorimetry.*

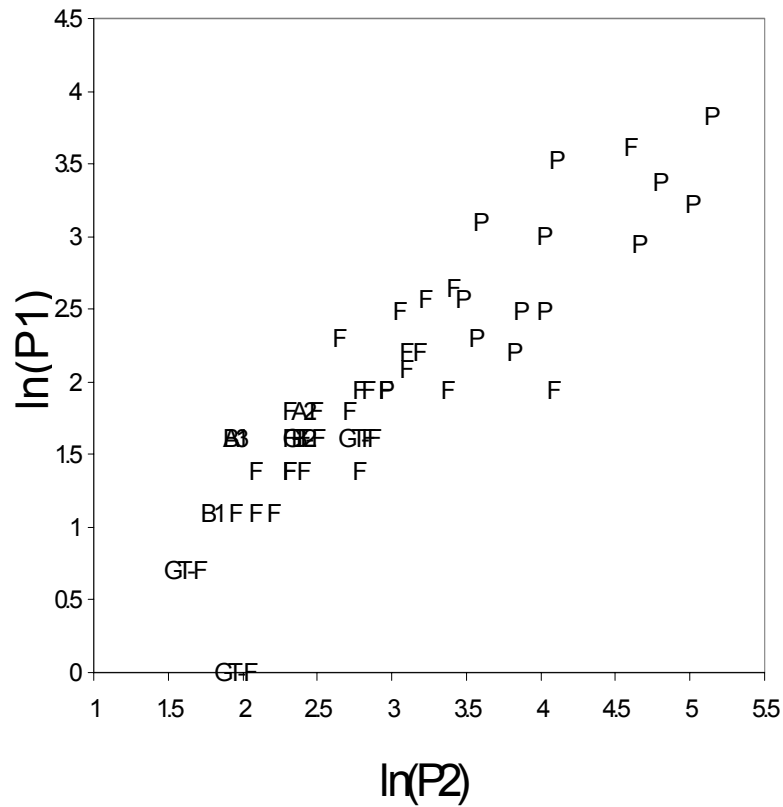
Figure 52. Relationship between P1 and P2 phosphorus extractions.
