The Story Behind the West Portico Steps

West Portico Steps

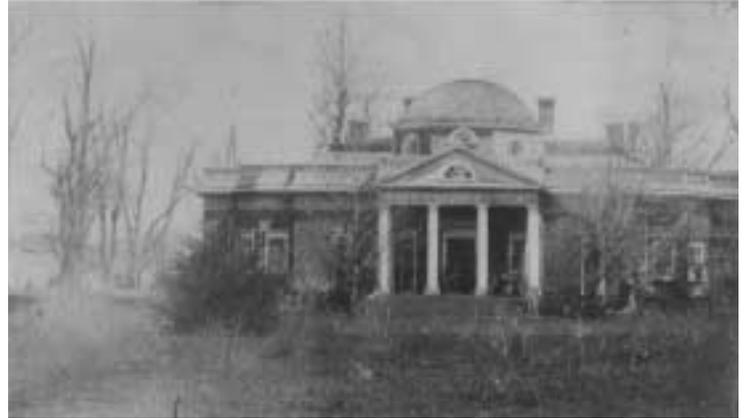
Photograph of Monticello's West Front, taken between 1870 and 1880.

All post-1850 images, however, show cheek walls with an earthen ramp between them.

social pressure to depict Monticello in a positive way had dissipated. These later images – like the indisputable photographs that date as early as 1860 – presented Monticello as it had been left, in an unfinished state. (A complete report on the West Portico steps research project is available online at www.monticello.org/icjs/archaeology/publications/westportico.pdf.)

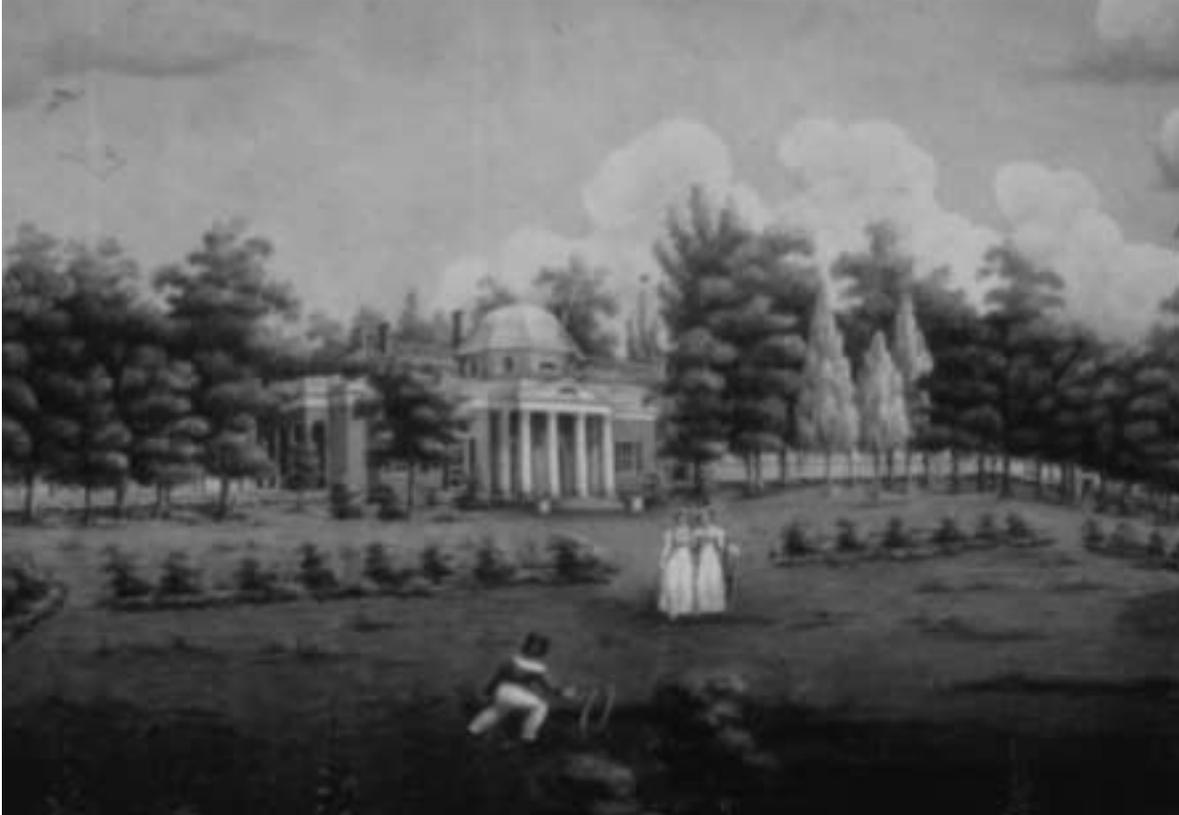
**View of
Monticello's
West Front,
painted by
Jane Braddick
Peticolas in
1825.**

while the others depict cheek walls as wide as the portico columns, which archaeological excavation has shown to be false.

The variations in the appearance of the West Portico in the pre-1835 depictions may have occurred because those artists felt a need to render Monticello in a way that would be considered appropriate by Jefferson or members of his family. The artists therefore created idealized versions of the house's architecture, substituting finished steps for wooden steps or the earthen ramp. Similarly, none of the three earliest depictions shows the unfinished West Portico columns, although documentary sources indicate that these were not masonry, but rather trunks of tulip poplar trees until the summer of 1822.
