Thomas Jefferson MONTICELLO

SPRING 2013

Columns Return to 'Rendered' Appearance

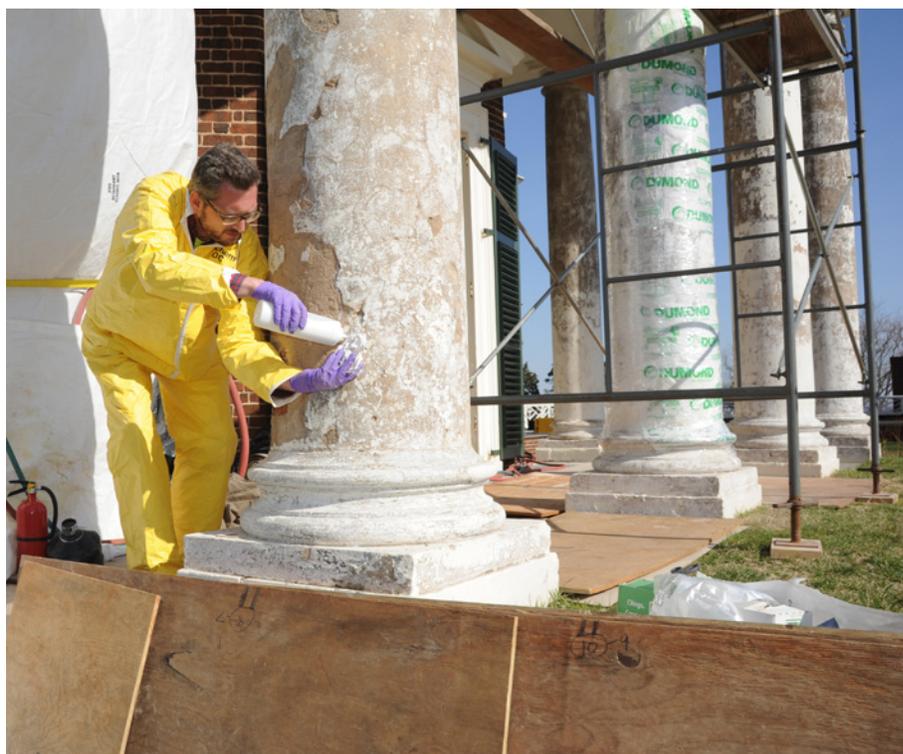
Architectural conservator Andrew Fearon reattaching loose rendering on the west column using an acrylic emulsion.

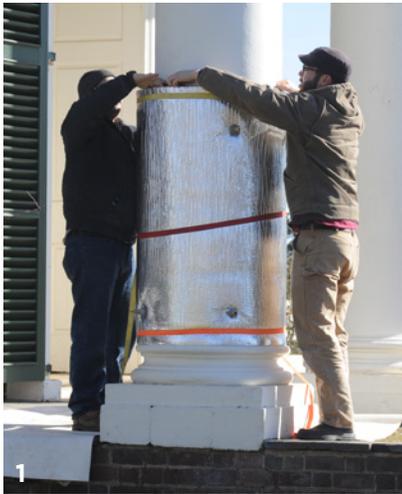
1

1. Conservation technicians Seth Gartland and Toby Canfield installing a custom-made steam jacket on the north column.

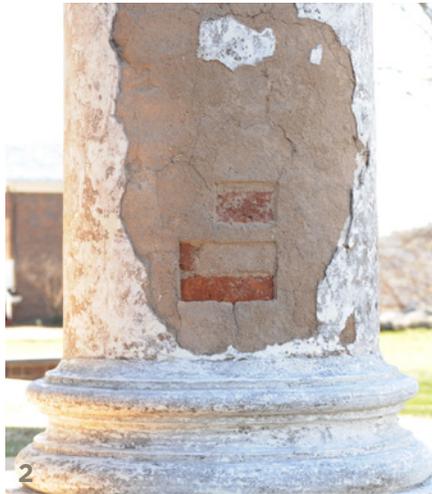
2

2. Area of failed rendering on the west column that will be repaired using a lime-based patching mortar. The squared-off areas are where samples were removed for analysis.

render will be repaired as necessary using period-appropriate materials; the earlier repairs will be repainted to match the historic surface. The final phase of the project is scheduled to be finished before the Fourth of July for all of Monticello's visitors to enjoy.

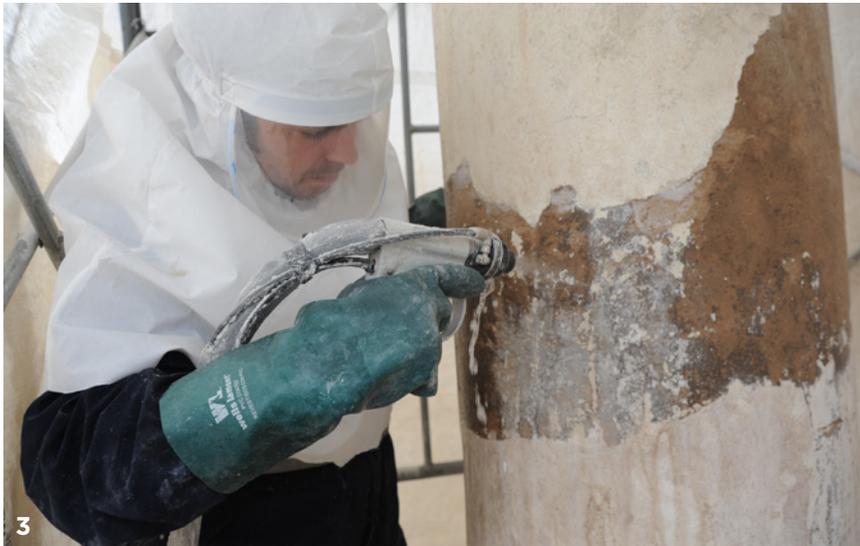
3

3. Conservation technician Seth Gartland executing the final cleaning of the surface using a special low-pressure blasting system originally developed to clean the Statue of Liberty.

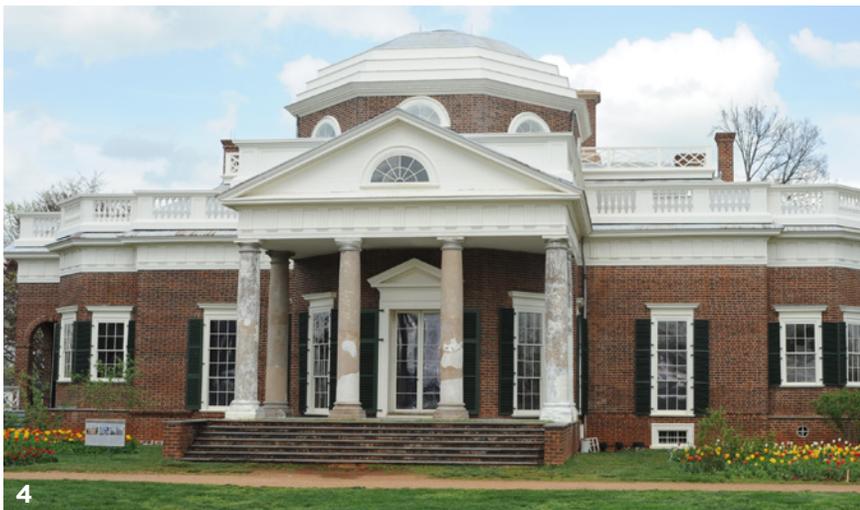
4

4. Overall view of the West Portico taken 4/12/13. Note older repairs on the lower portion of the two middle columns.

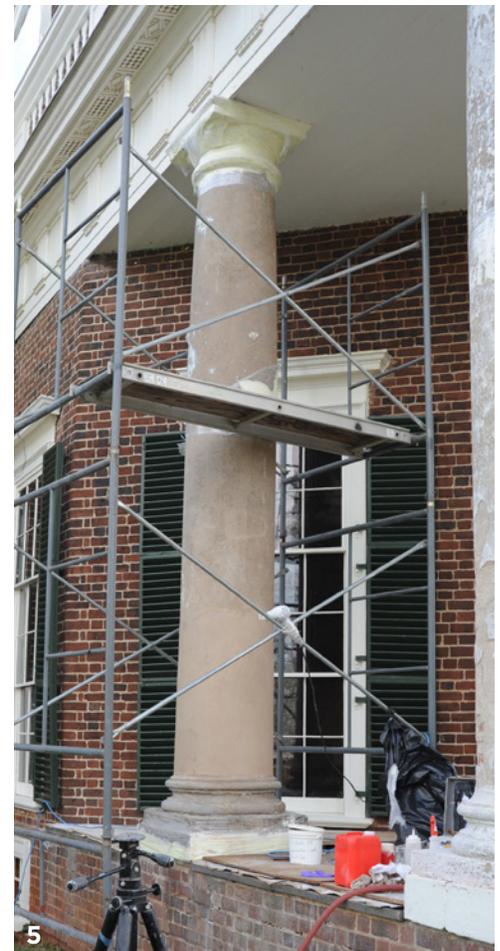
5

5. North inner column nearing completion. The older repair area on the lower quarter of the shaft has been in-painted to match the original rendered surface.
