# Monticello's West Portico Steps: New Archaeological Evidence

*by Sara Bon-Harper*  
*with a mortar analysis by*  
D. S. Lane

May 2001

MONTICELLO DEPARTMENT OF ARCHAEOLOGY TECHNICAL REPORT SERIES  
NUMBER 4

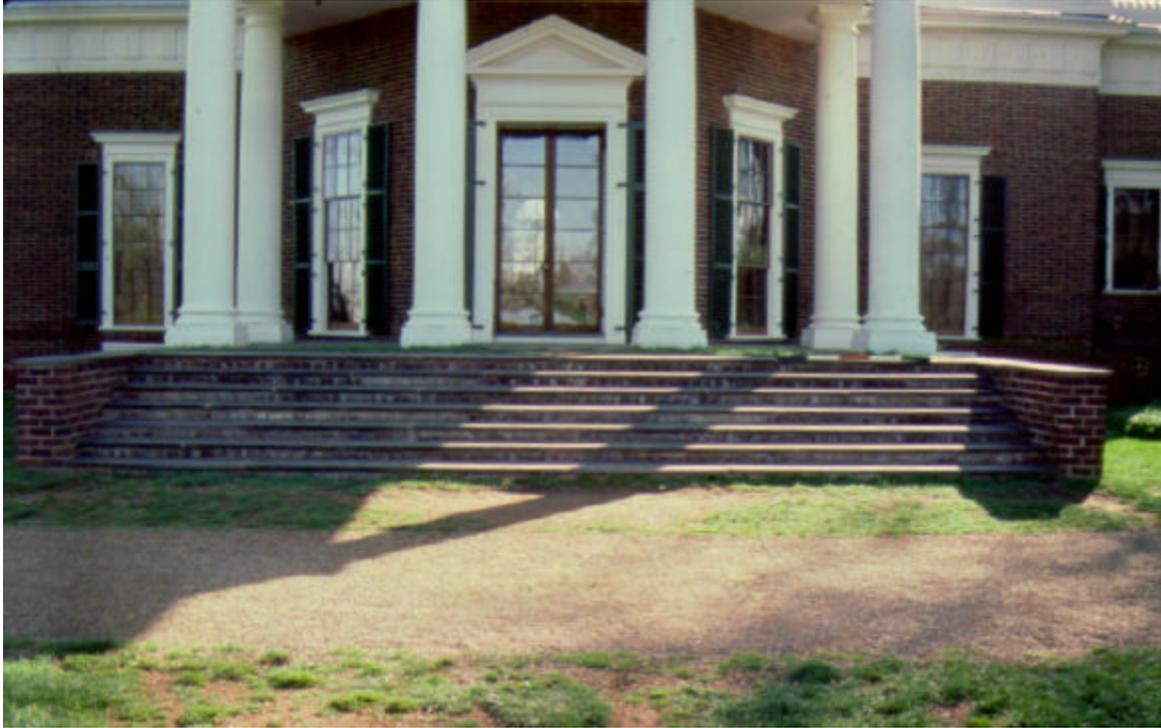
**Figure 1.** *The West Portico before excavation, April 1999.*

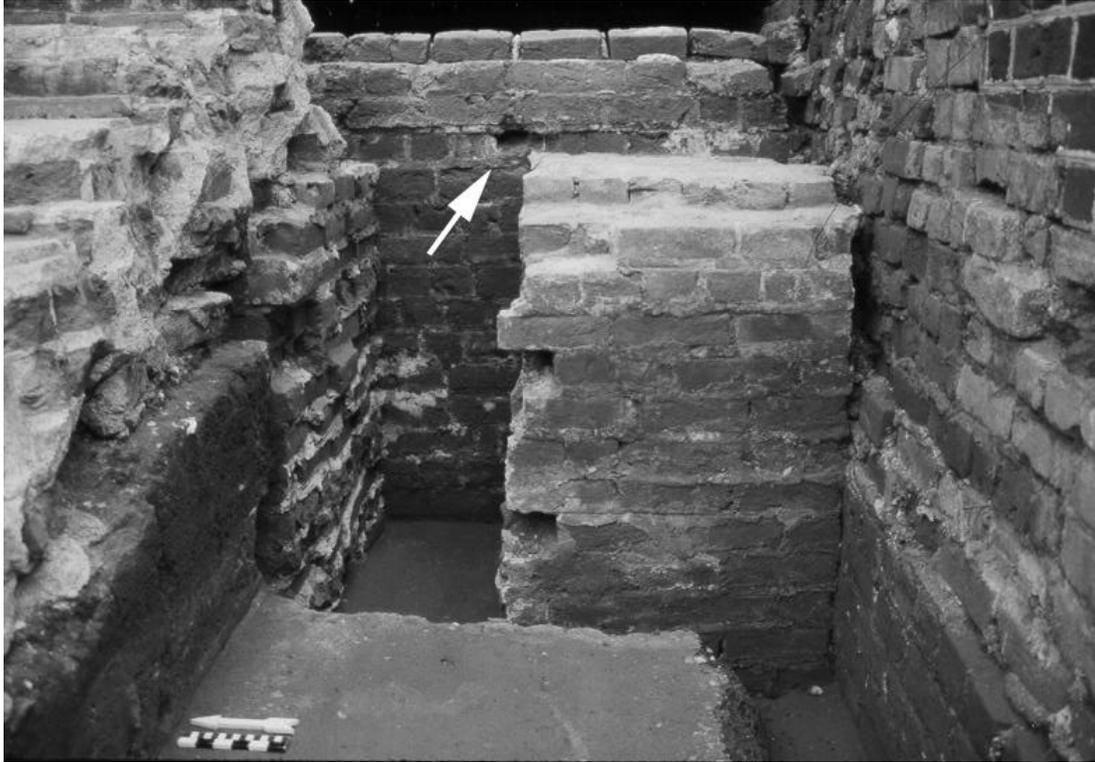
**Figure 7.** Section through 2150D, revealing pocket in Jefferson-period headwall.

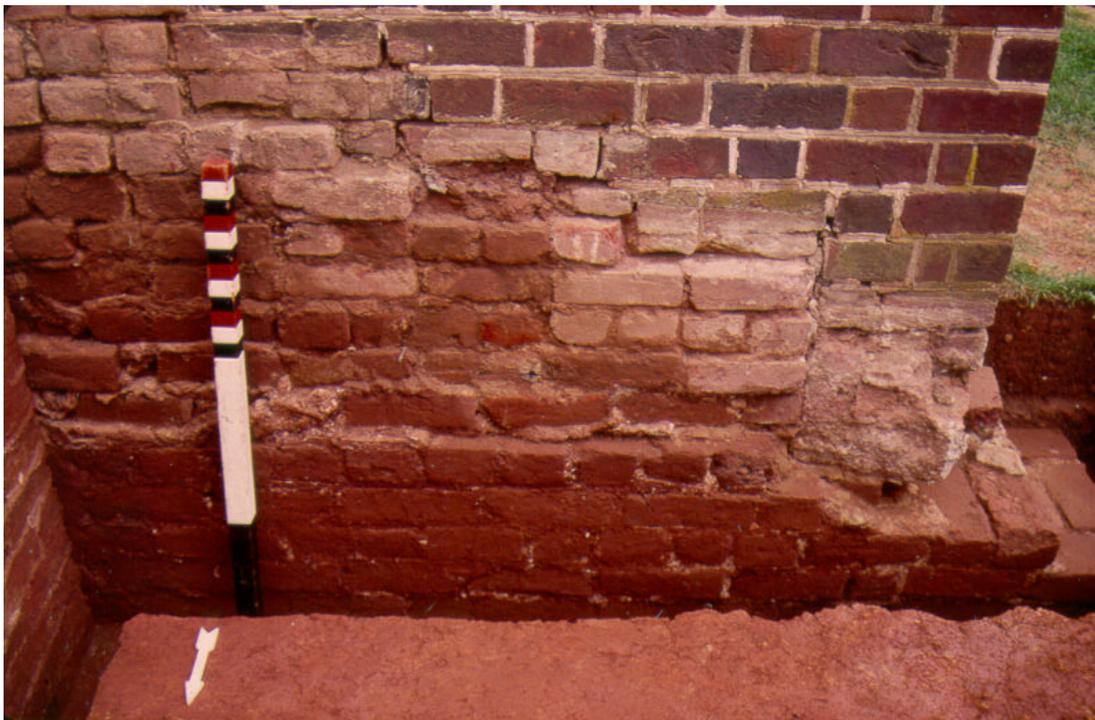
**Figure 8.** South cheek wall, north face.

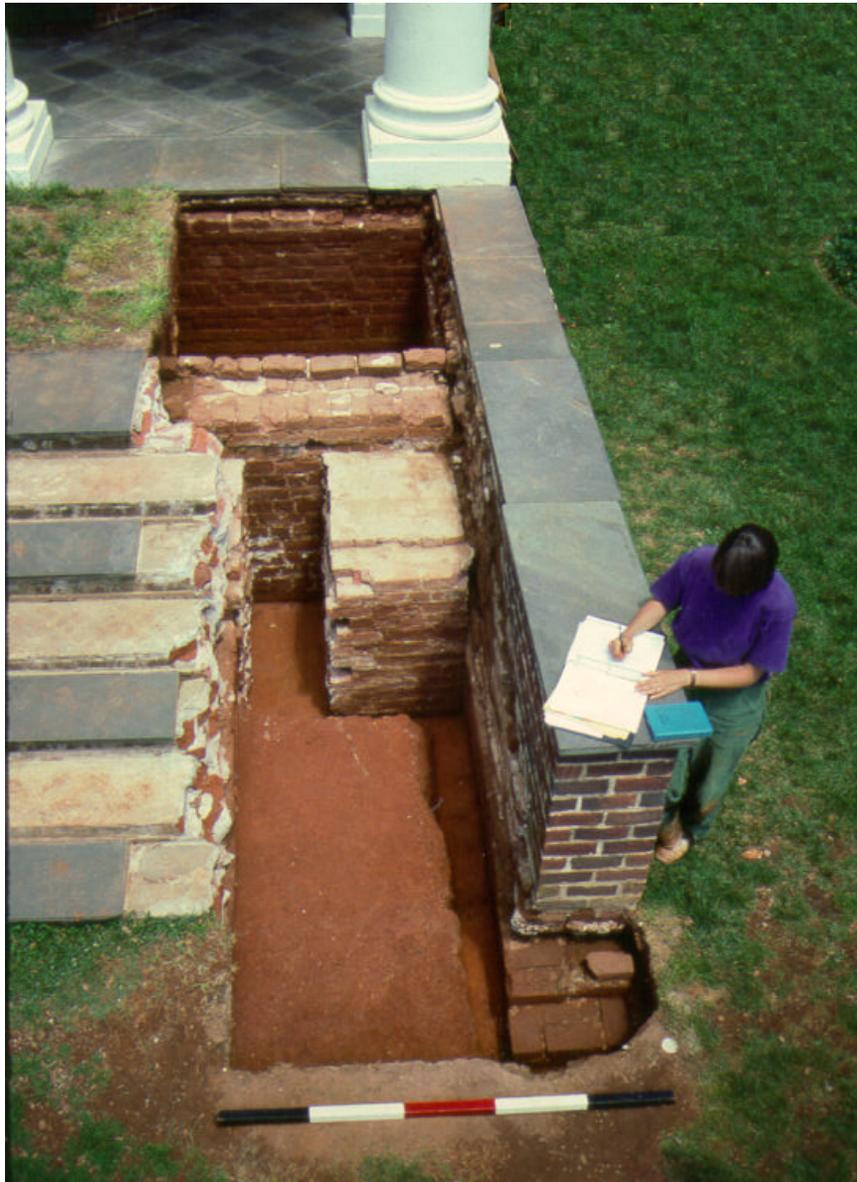
**Figure 10.** *End of excavation facing east, showing section through 2150D.*

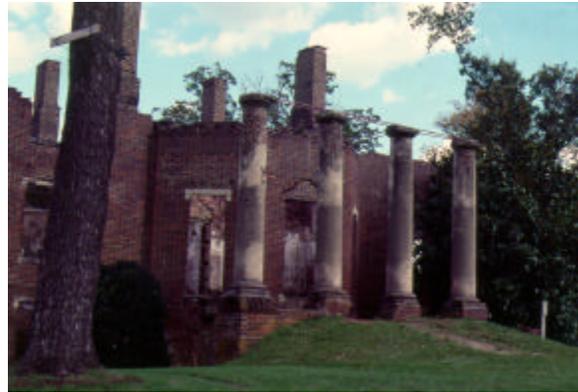
**Figure 12.** Earthen ramp at Barboursville (Orange County, Virginia, 1999).

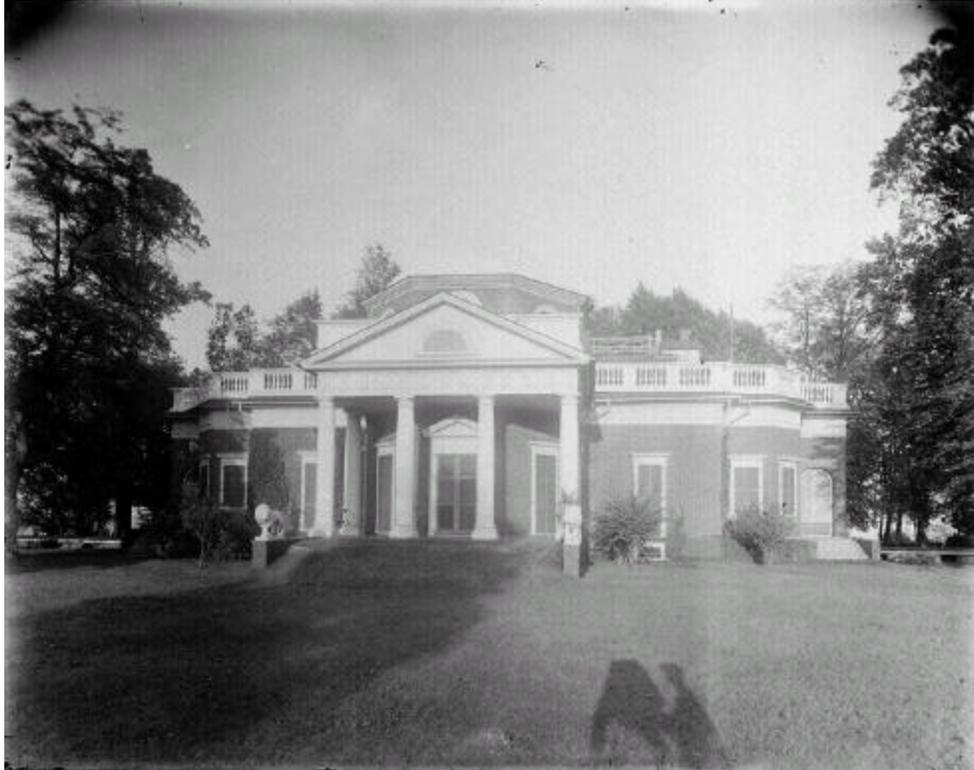
**Figure 13.** *Holsinger photograph of the West Portico (undated).*

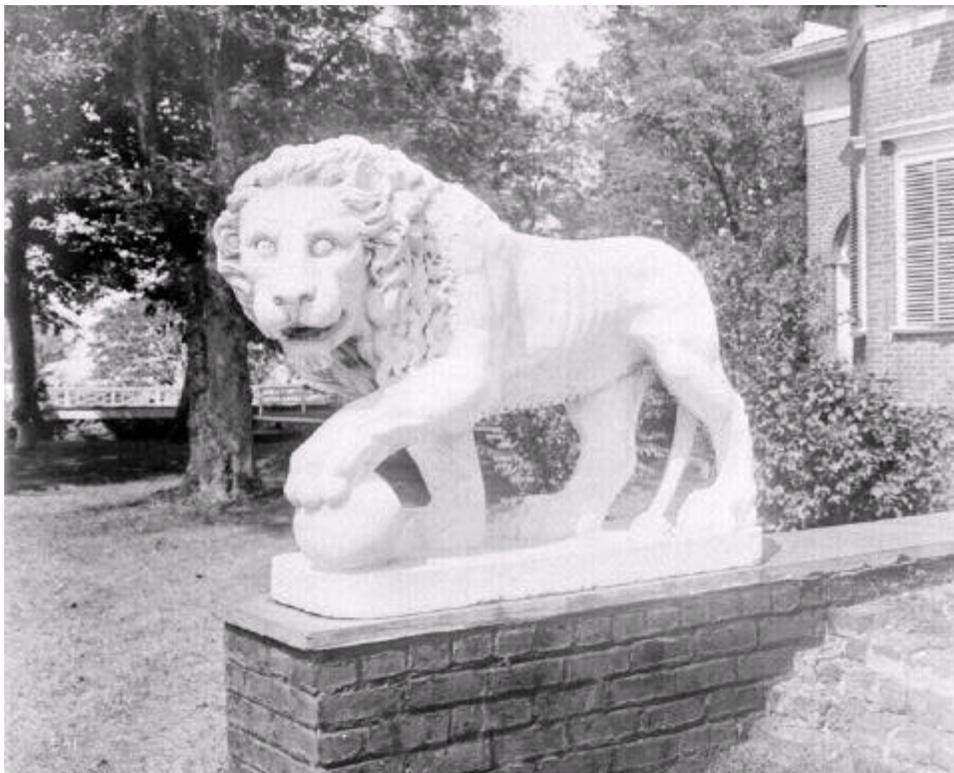
**Figure 14.** *Holsinger's 1912 photograph of lion statue on north cheek wall of the West Portico.*
